PORT OF PORTLAND

DRY DOCKS 1 & 2 AT MARINE TERMINAL 1

HAZARDOUS MATERIALS INVESTIGATION

**PBS Project Number
4810.83**

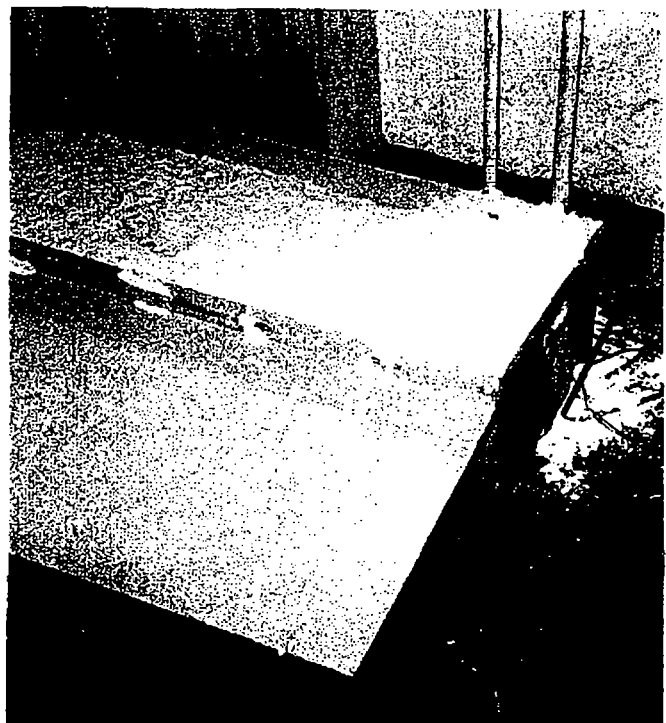
STORAGE LOCKER FULL OF FRIABLE MAG INSULATING CEMENT; APPEARS TO CONTAIN AMOSITE ASBESTOS.

- a. Remove storage lockers of friable mag block insulating and asbestos insulating cement.
 - b. HEPA-vacuum friable asbestos debris accumulations and tack-coat/encapsulate the immediate areas where debris has been removed.

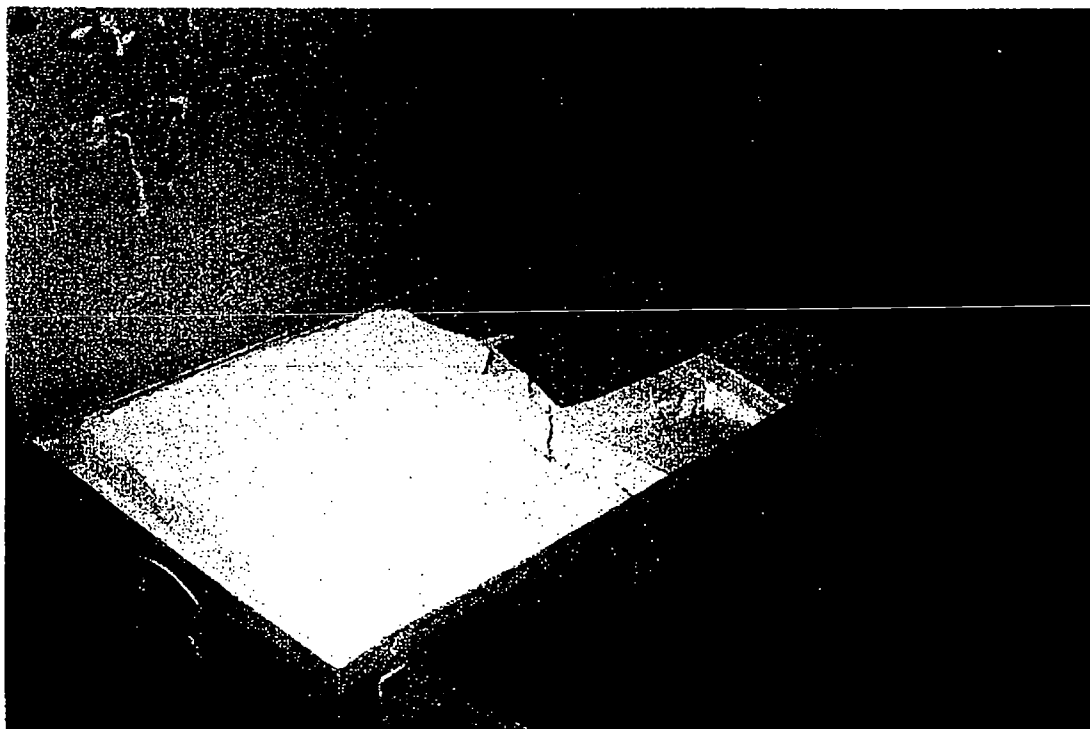
STORAGE LOCKER FULL OF FRIABLE MAG BLOCK INSULATION;
APPEARS TO CONTAIN AMOSITE ASBESTOS.

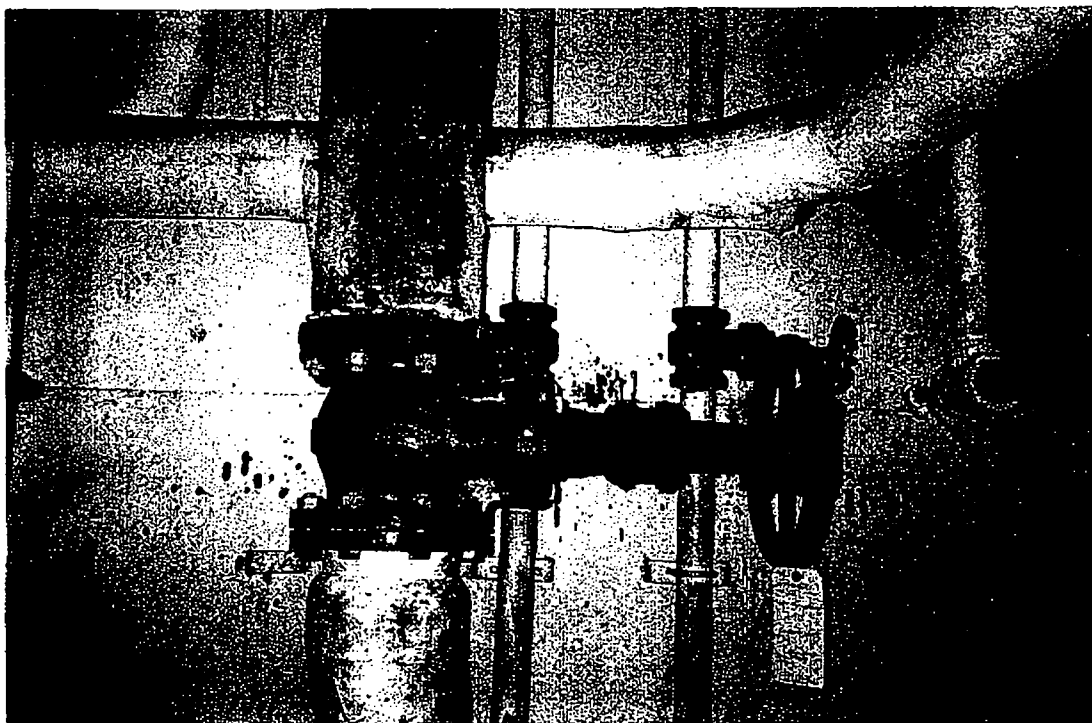
MAG PIPE INSULATION NOT LABELED. MOST PIPE INSULATION IS IN GOOD CONDITION,
EXCEPT ENDS WHERE EXPANSION/CONTRACTION HAS EXPOSED FRIABLE INSULATION.

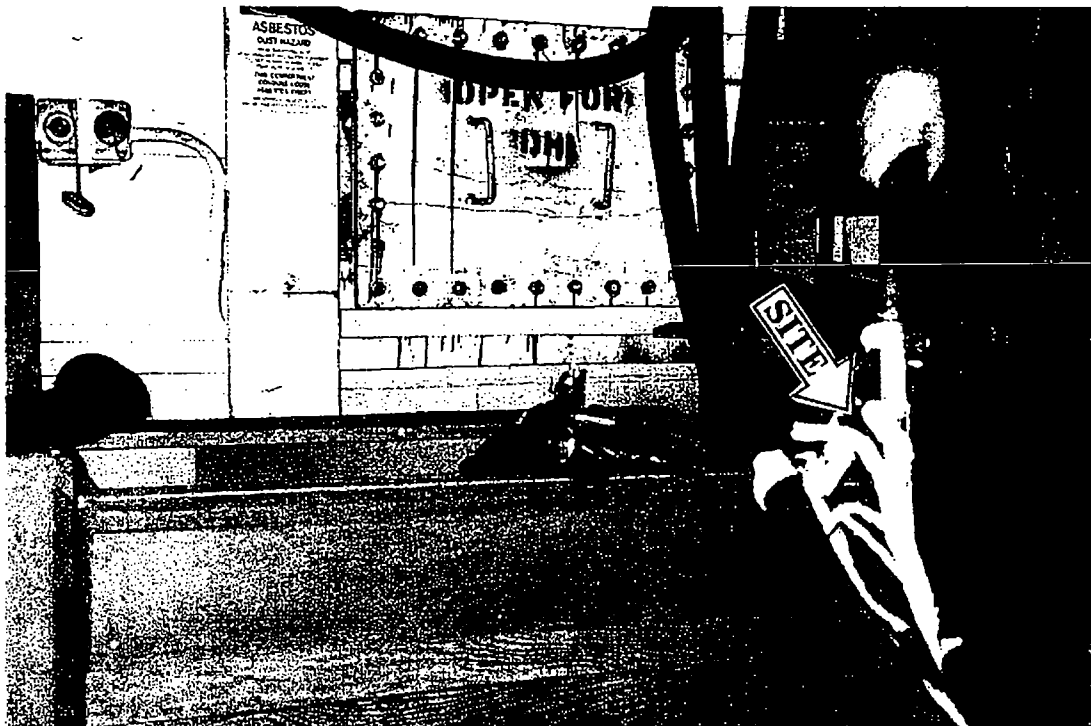
ASBESTOS ROPE INSIDE 3" RUBBER COATED ELECTRICAL "BALONEY" CORD; ROPE EXPOSED AT ARROW; NOTE "DANGER ASBESTOS" SIGN IN BACKGROUND.

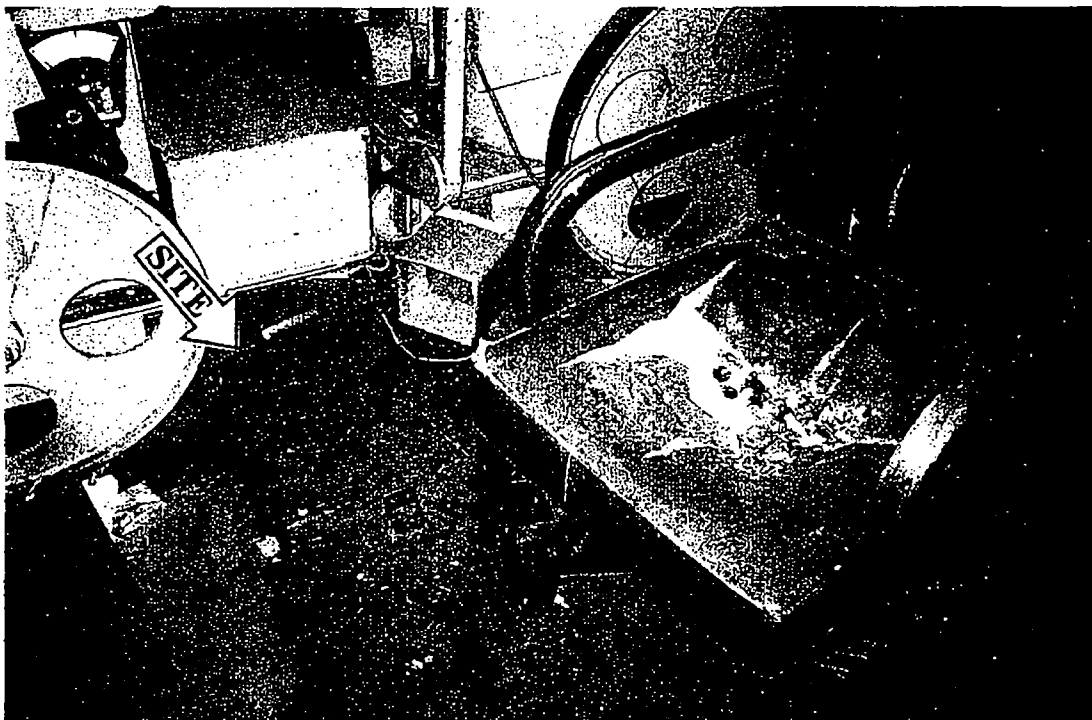
SUSPECT GARLOCK GASKETS AT ARROW, TYPICAL; WELDING SLAG IN CHAIR MAY CONTAIN LEAD, CADMIUM OR SILVER (NOT TESTED).

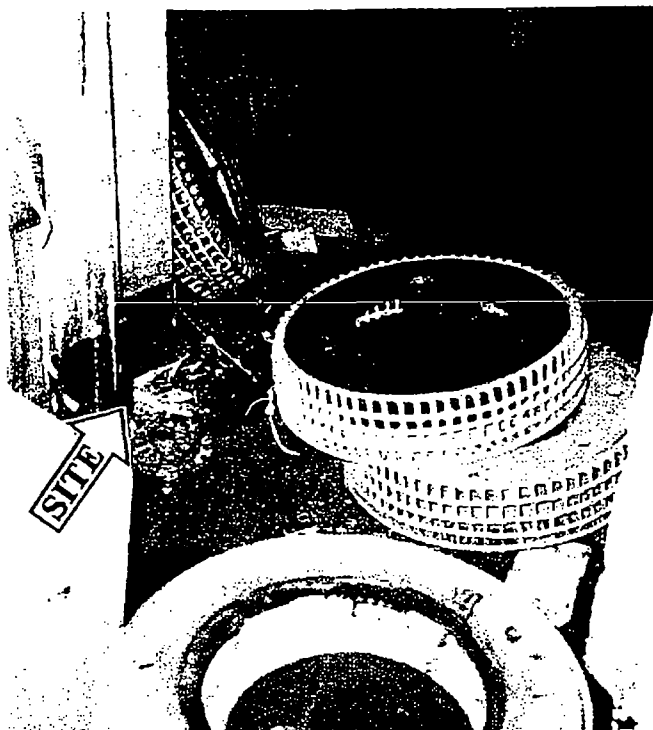
PEELING PAINT AT ARROW; DEBRIS THROUGHOUT FLOORS POSES TRIP HAZARDS.

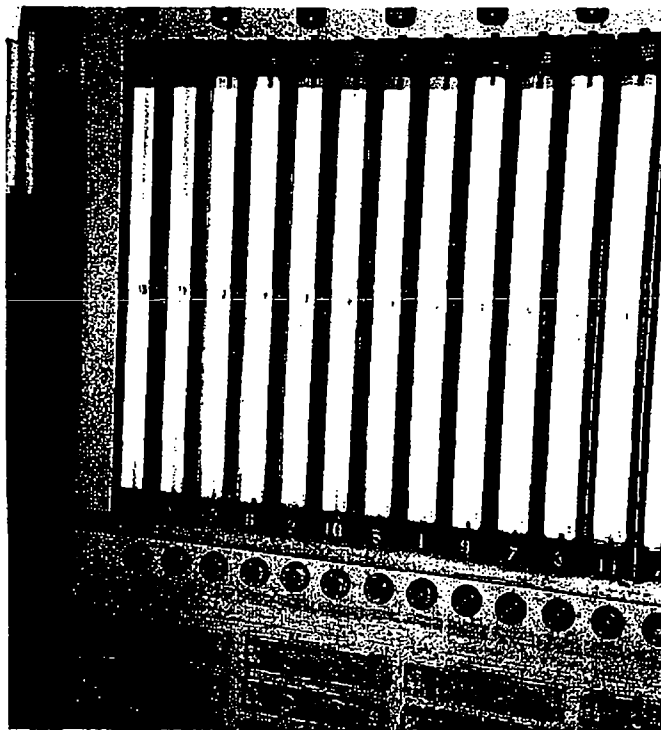
MERCURY CONTAINING MANOMETERS IN GOOD CONDITION.

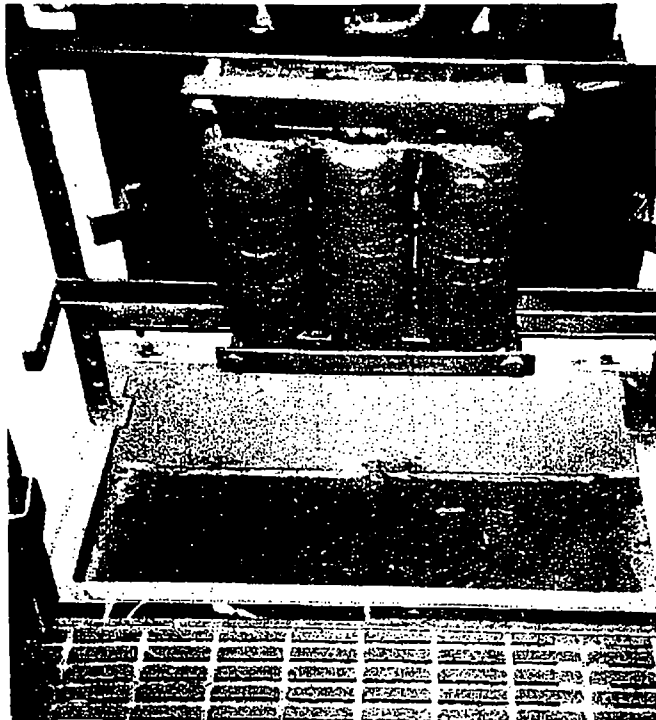
LEAKING OIL/SLUDGE AT BASE OF TRANSFORMER; TESTED NEGATIVE FOR PCB'S.

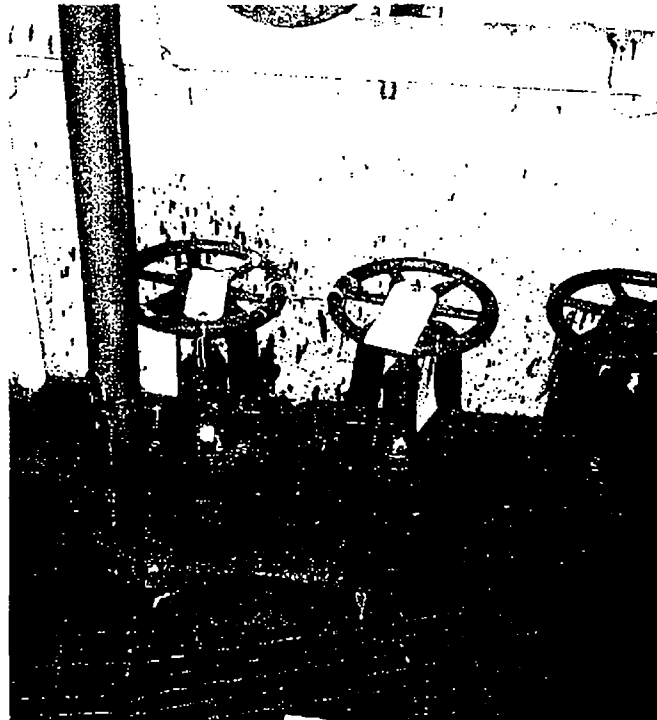
VALVE OIL ON EQUIPMENT AND WALLS/FLOORS, TYPICAL (NOT TESTED).

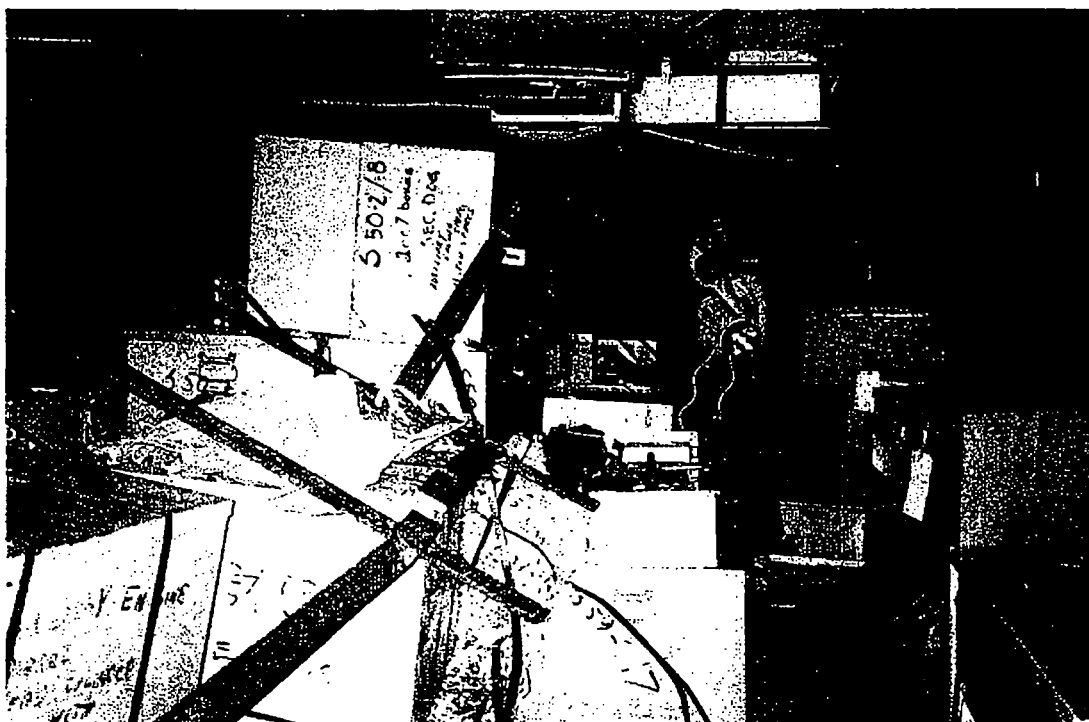
STORED ITEMS POSE TRIP HAZARDS THROUGHOUT, TYPICAL.

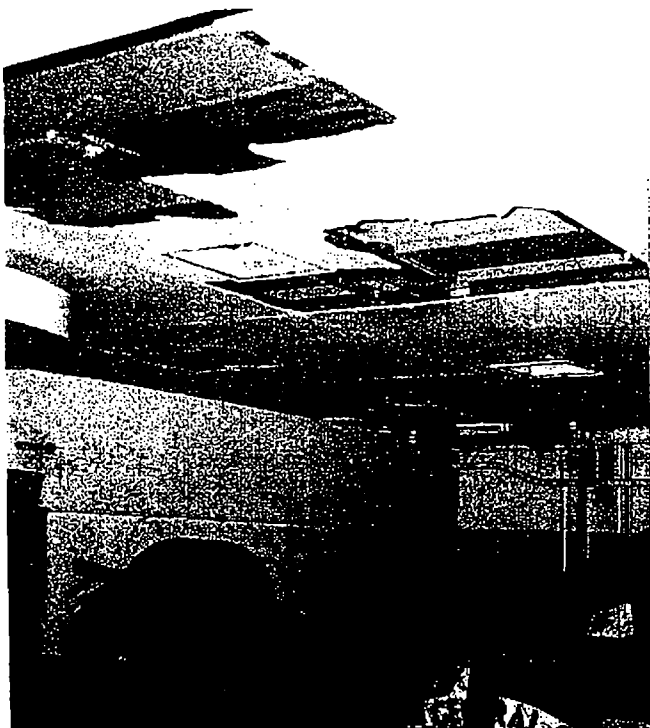
DAMAGED 1/4" CEMENT ASBESTOS CEILINGS.

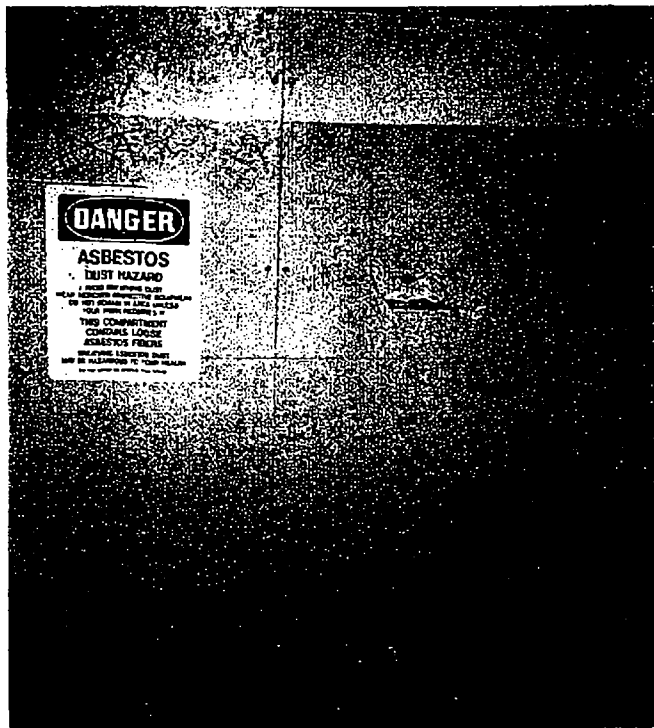
DAMAGED 1/4" CEMENT ASBESTOS WALLS.

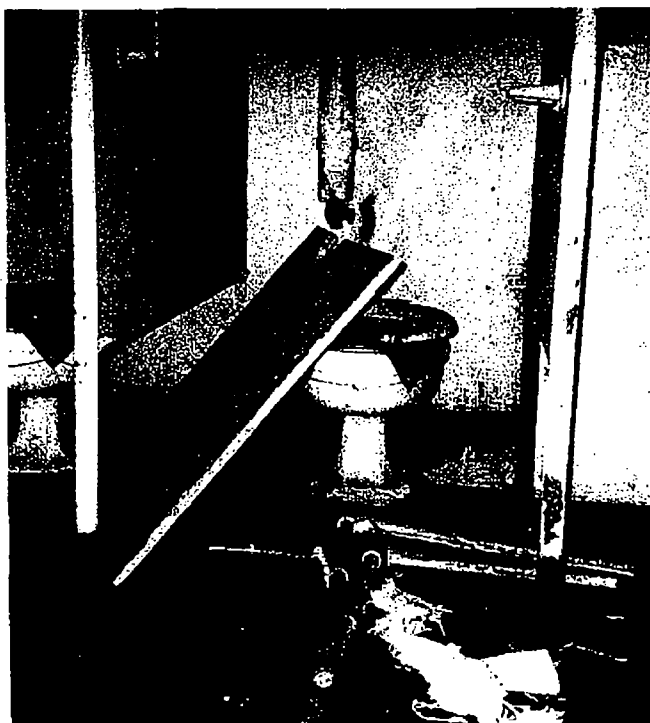
DAMAGED ONE INCH THICK CEMENT ASBESTOS BOARD; FRIABLE SUSPECT CHRYSOTILE TEXTILES AND DEBRIS ON FLOOR.

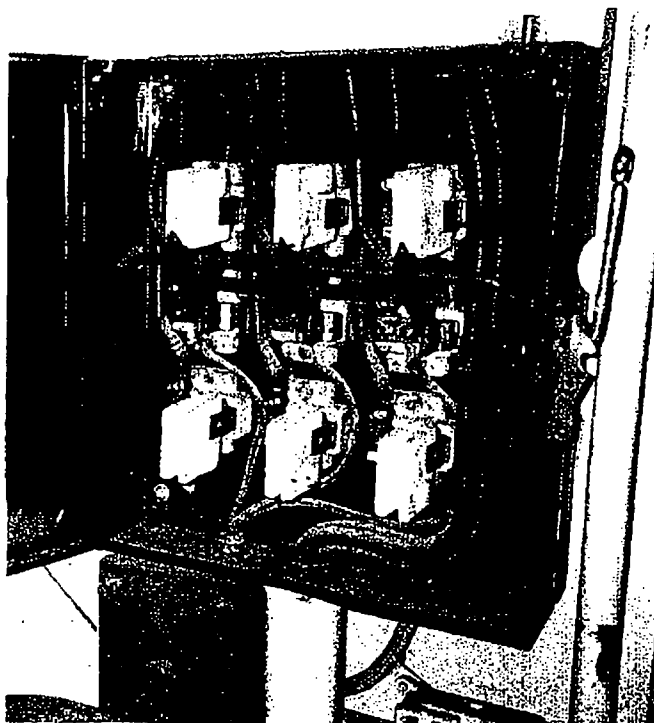
CEMENT ASBESTOS INSULATING BLOCKS ASSOCIATED WITH ELECTRICAL EQUIPMENT.

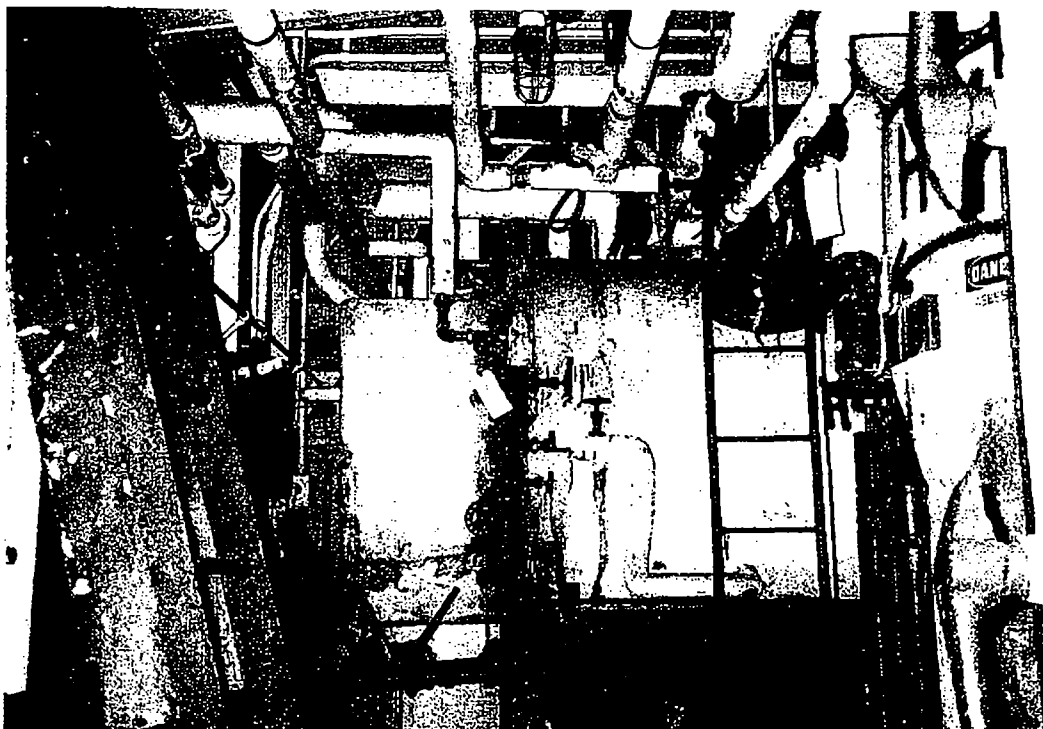
MAG BOILER, TANK AND PIPE INSULATION IN FAIR CONDITION, TYPICAL.

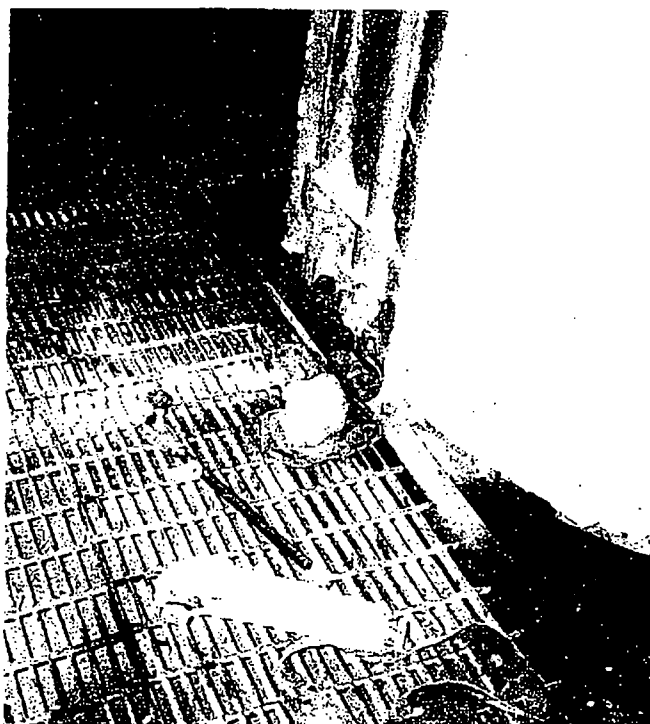
LIMITED AREA OF SEVERE PIPE INSULATION DEBRIS/POWDER.

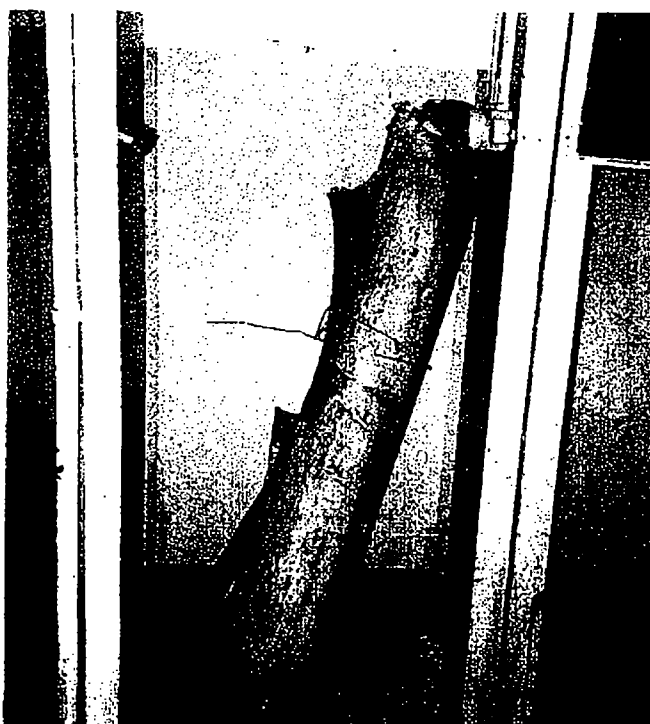
SUSPECT ROLLED SHEET GASKET MATERIAL; MODERATELY FRIABLE.
